## External Condensation

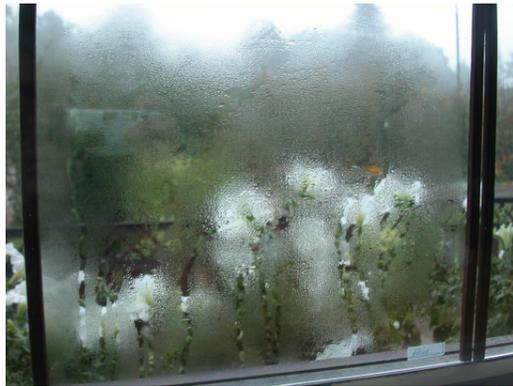
The condensation of water on the external surface of a window results in the formation of small water droplets spread across the surface. This has a detrimental impact on the visual appearance of the window – particularly a loss of visual clarity when looking out of the window. The effect is caused by light scattering in the water drops and is shown in the photograph below.

**Photo showing visual impact of external condensation on glass.<sup>4</sup>**

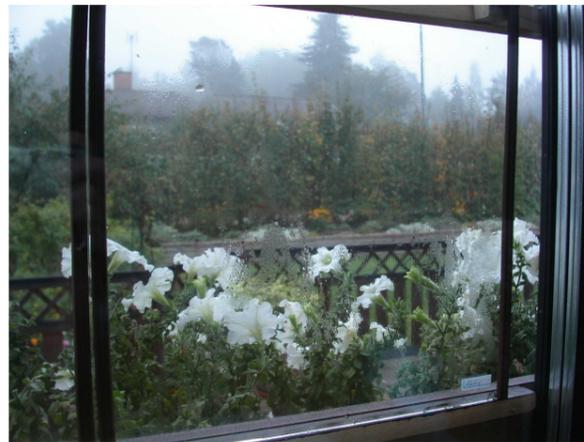
Work is now underway to identify whether coatings on the exterior surface of the insulated glass unit can reduce this loss of visual clarity due to external condensation. Initial results have demonstrated that whilst not affecting the onset of external condensation, the use of Pilkington Activ™ self cleaning glass can improve the visual appearance of the glass when exterior condensation occurs. Pilkington Activ™ is a dual action coating which when exposed to natural sunlight is photoactive and hydrophilic. The photoactivity aids the decomposition of organic dirt on the surface, and the hydrophilic action causes the condensed water droplets to spread out more on the surface than on ordinary glass. The water droplets then tend to form a sheet of water which has been observed to reduce the visual impact of the external condensation as well as allowing it to dissipate quicker.

**Photo Showing Pilkington Activ™ With External Condensation. Note deterioration in visual impact is significantly reduced due to sheeting of water over surface.<sup>4</sup>**
